# Heavy Price of Poor Maintenance and Sloppiness

*"Poorly maintained equipment and sloppiness can lead to serious accidents."*

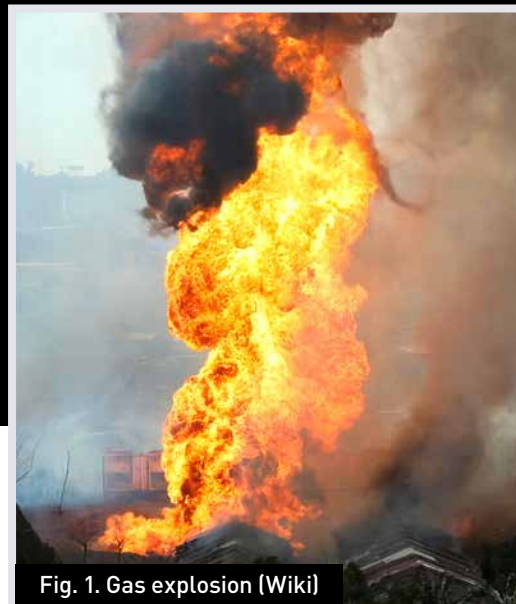
Fig. 1. Gas explosion (Wiki)

We can encounter this old truth in preamble almost every day in various areas of economic activities. The latest dramatic explosion in a Malaysian (April 1, 2025) gas pipeline (**Fig. 1**) would be a reminder. Leaks in the gas pipeline send fire spreading to villages.

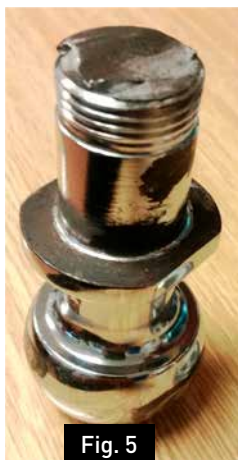
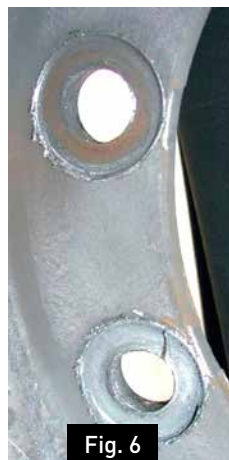
Fig. 4

Fig. 5

Fig. 6

An error in choosing the material for the car wheel mounting bolts and their excessive strain (**Fig. 4 - 6**) caused a serious traffic accident.

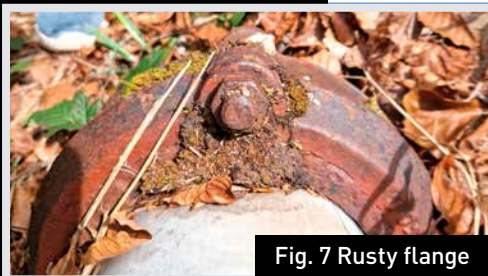
Fig. 7 Rusty flange

- Corrosion (**Fig. 7 - 9**)
- Loosening of bolted joints
- Damage to the seal on flanges

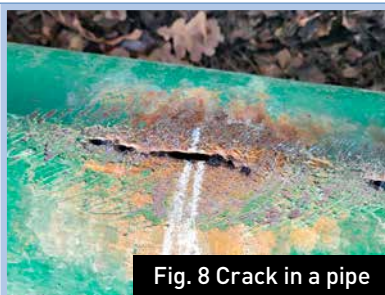
Fig. 8 Crack in a pipe

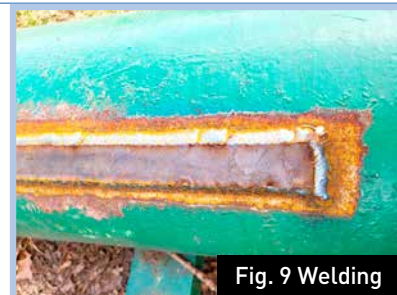
Fig. 9 Welding

atmospheric corrosion and internal corrosion as a result of the effect of aggressive components contained in the transported medium. It is not uncommon for it to be a combination of both. Welding a steel sheet (Fig. 9) is only effective for a short time. If the area around the weld is not treated properly, it corrodes very quickly.

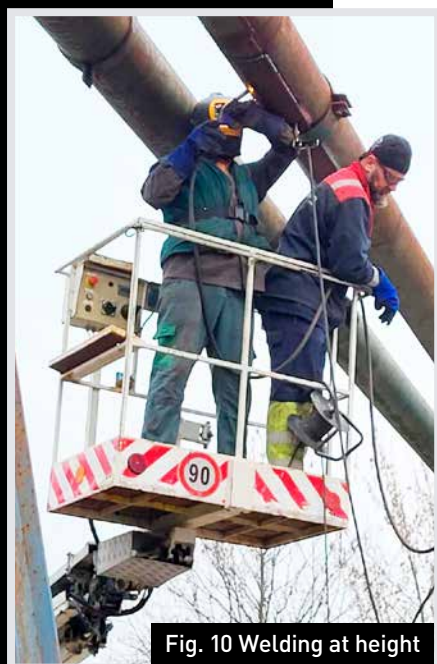
Fig. 10 Welding at height

It is also important to take into account the fact that pipe repairs often take place in hard-to-reach places (Fig. 10). Sometimes it is a difficult and expensive matter. Not only pipeline repair at height is at least twice as expensive, it is also more difficult than on the ground. The same applies to routine checks of the condition of bolted joints in hard-to-reach places.
