Martensitic Stainless Steel in the Manufacture of Screws

Symbiosis of Performance and Durability

by Jozef Dominik

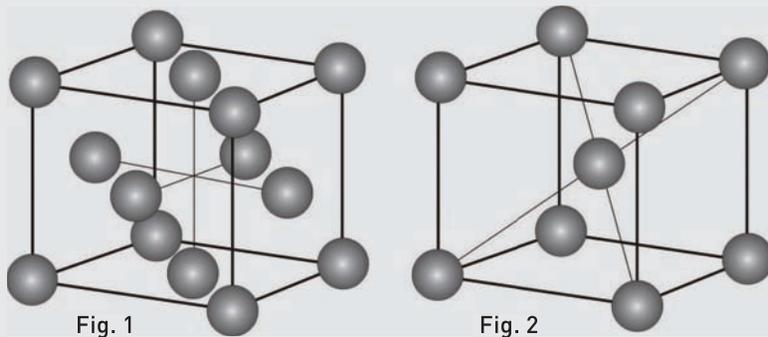
Contrary to austenitic stainless steels, e.g. A2 or A4, in which the basic microstructural element is an austenite (paramagnetic γ -phase with a cubical, face-centered elementary grid - *Fig. 1*) the final microstructure of martensitic steels is created by a martensite (a ferromagnetic α -phase with a cubical spatially-centered elementary grid - *Fig. 2*) which is a product of hardening.

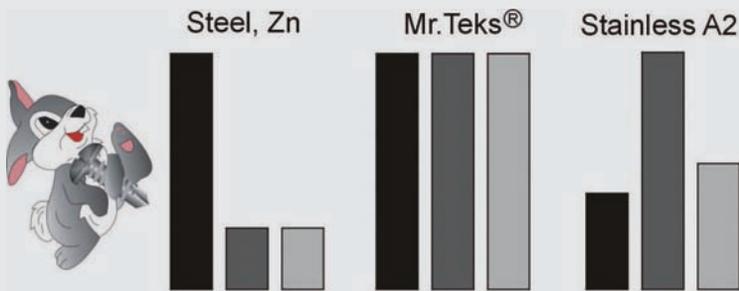
Fig. 3 ■ drilling performance ■ corrosion resistance ■ price
Mr.Teks® - mrteks.sk - stainless martensitic steel screws

The given alloying system provides not only strong resistance against corrosion comparable with A2 steels, but also an excellent combination of mechanical characteristics (*Fig. 3*).

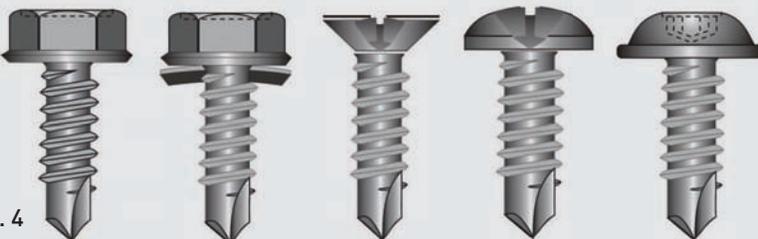
Fig. 4

Specifically martensitic stainless steels are used to produce self-drilling screws (*Fig. 4*). They are applied mainly to the outer sheathing of the building (*Fig. 5*) and to the isolation of various industrial installations such as boilers, filters and others.

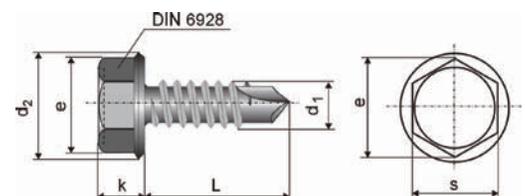
Fig. 6

We tested the DIN 7504K bolts ($d_1 = 4.2\text{mm}$ and $d_1 = 5.5\text{mm}$ from two different manufacturers) (*Fig. 6* and 7).

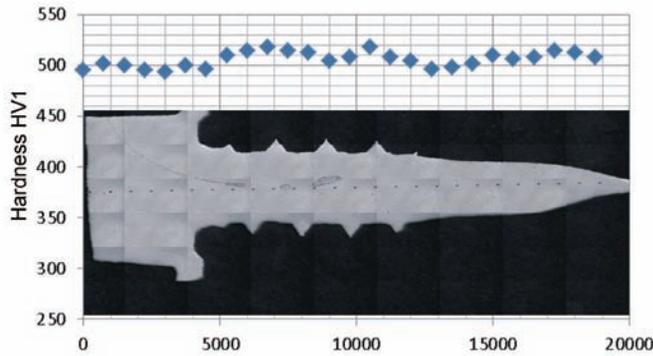
Fig. 8 [μm]

The hardness of the screws was measured according to the Vickers method HV1 along the unetched cut screws. The measurement results are shown in *Figures 8* ($d_1=5.5\text{mm}$) and *Figures 9* ($d_1=4.2\text{mm}$).

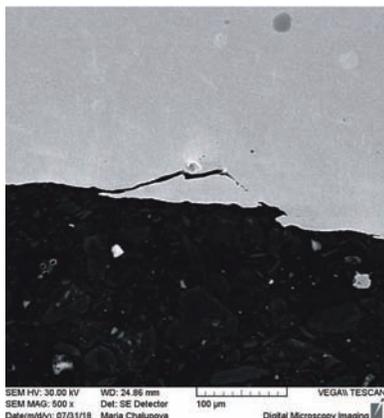
Fig. 10

On the unetched state the presence of microcracks was evaluated (*Fig. 10*). Microcracks occurred in specimen $d_1=4.2\text{mm}$ and were likely to have occurred during the rolling of the screws. The microstructure was induced by the solution Kallings 2. Both samples were martensitic (*Fig. 11*), which corresponds to a hardened condition.

In terms of chemical composition of steel, microstructure and hardness, there were no significant differences between the samples. In all cases, it is a hardened martensitic stainless steel. Also, during the assembly, the samples behaved identically. Microcracks on the screws ($d_1 = 4.2\text{mm}$) did not appear negative during the assembly test. ▣
