Latent Corrosion of Screw Connections

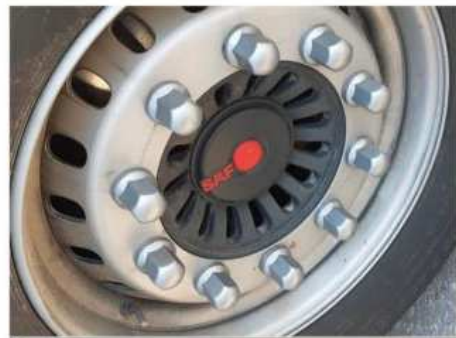
Fig. 5

Another example of latent corrosion of screws is worth mentioning. As C. O. Bauer writes in his book "Handbuch der Verbindungstechnik" (Hanser Verlag München, 1991) particularly dangerous can be "protective caps" (Fig. 5).

These caps are often used in truck traffic in a misconception that they protect the wheel nuts against corrosion. The truth is, however, that these caps will never completely leak and due to the effect of capillary forces is absorbed the humidity and creates inside the caps an aggressive microclimate. Moreover, the plastic caps aging and cracking over time, so the situation gets worse. Unshielded wheel nuts without caps are less prone to corrosion and especially the complete screw connection is visible to the naked eye. The case is analogous to Fig. 1.
